ERDC/CRREL TR-03-8

Remote Determination of Bridging/Fording Sites

Barry Coutermarsh and Sgt. Benjamin Dwinal

April 2003

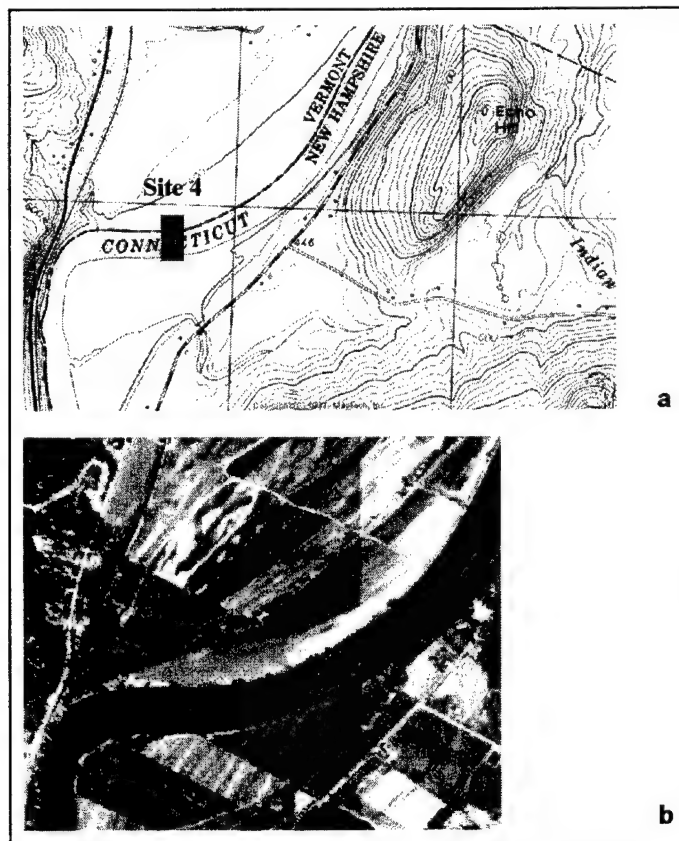
The predominant reason why crossing sites were unacceptable was the vertical height and slope of the riverbanks. It is nearly impossible to determine vertical height from overhead aerial imagery, and the contour interval of 20 ft on the USGS maps is too coarse for the resolution needed for a river crossing. Figure 2 shows the contour map and 1-m imagery in area 1 that was used to select crossing site 4. The contour map indicates flat ground and gentle slopes next to the river. The 1-m imagery confirms that the areas are fields with sparse vegetation along the riverbanks. For these reasons, it looked to be a potential crossing site.

Figure 2. Site 4: Contour map (a) and aerial imagery (b).

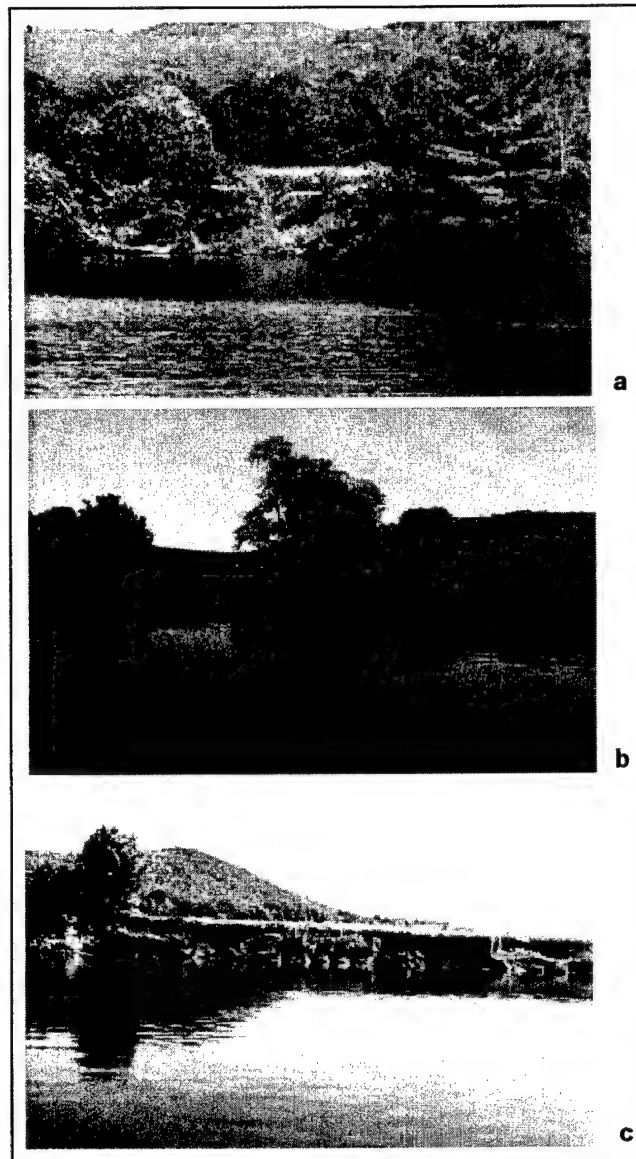
Figure 3 shows the east and west banks. It can be seen that there is room between the sparse vegetation for vehicles to move, but the bank has a steep slope, about 45° , and a 10-ft height. The west bank is about a 90° slope with an exposed sandy face between 10 and 15 ft high. Vehicle movement would be impossible on the west bank and very difficult at best on the east bank after the surface got wet and rutted from several passes.

Figure 3. Site 4: East (a and b) and west (c) banks.

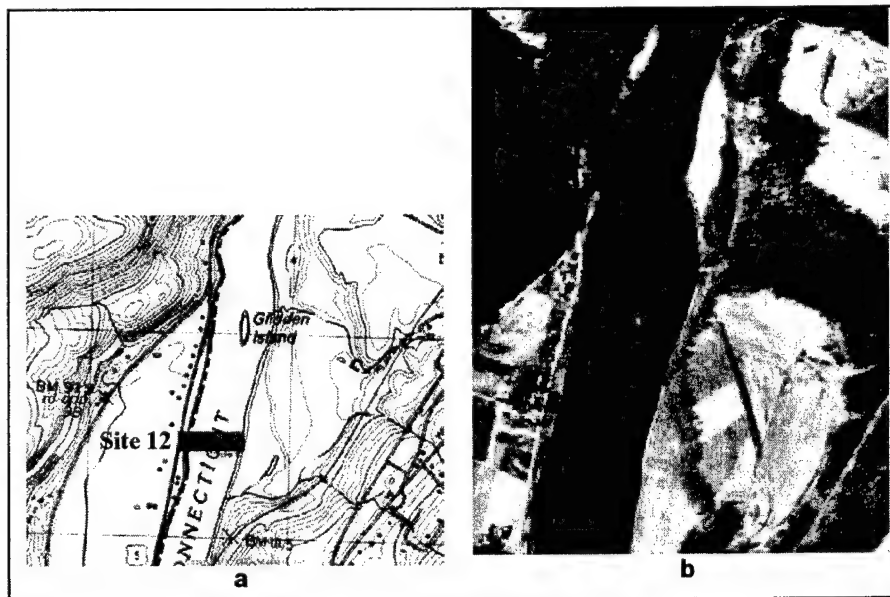
Area 2, the southern study area on the Connecticut River, presented more difficult terrain for river crossings. Only one location, site 12 (Figure 4), was remotely identified as a possible crossing site. The contour map indicates a large flat area on both the east and west sides of the river. There is a contour line near and parallel to both sides of the river, but from the map and aerial imagery it is difficult to tell how high a bank there is, if any. A shadow along the west bank indicates some bank height, but the east bank shows no such indication because the sun is shining onto it from the west.

Figure 4. Site 12: Contour map (a) and aerial imagery (b).

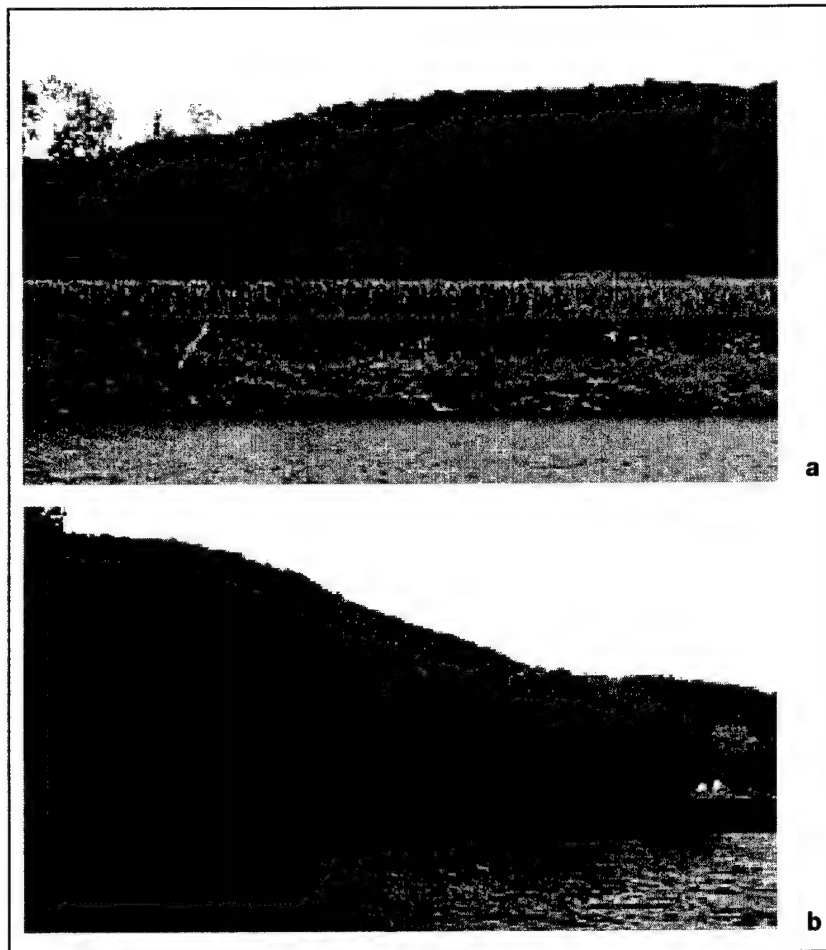
The field inspection (Figure 5) revealed the east bank to be 10 to 15 ft high at a 90° slope and the west bank to be 8 to 12 ft high at almost a 90° slope.

Figure 5. Site 12: East (a) and west (b) banks.

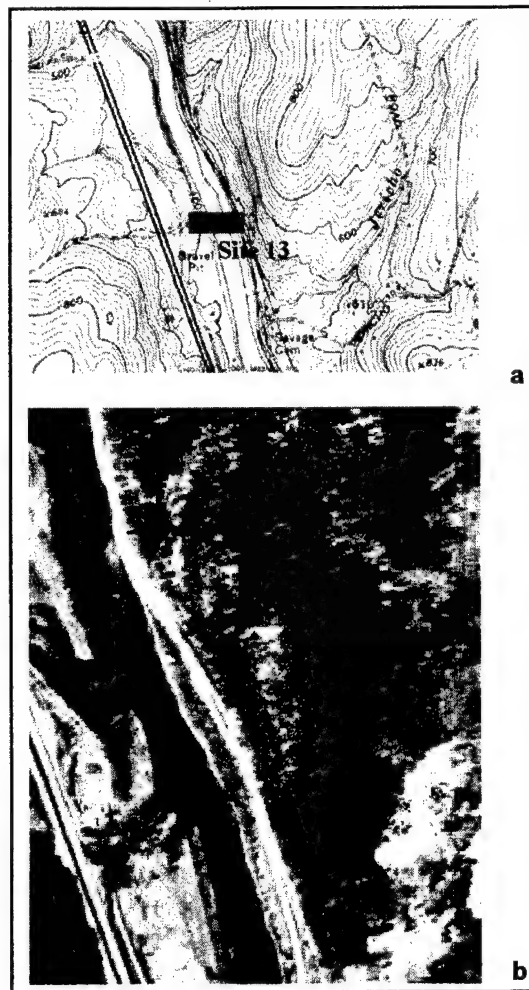
Figure 6 shows the contour map and imagery for site 13 in area 3 on the White River. The contour map shows a flat area just north of Savage Cemetery on the east side of the river that appeared to be acceptable as a crossing site. The west bank shows vegetation on the USGS map but looks to be relatively flat otherwise. The aerial imagery shows the areas as mostly fields with a sparse tree line behind them. The sun angle reveals the possibility of a bank on the west side of the river, but the east bank is indeterminate. In addition, although it is difficult to see in the shadow, there is a strip of land to the east of the trees on the west bank that was thought to be a corridor to the river.

Figure 6. Site 13: Contour map (a) and aerial imagery (b).

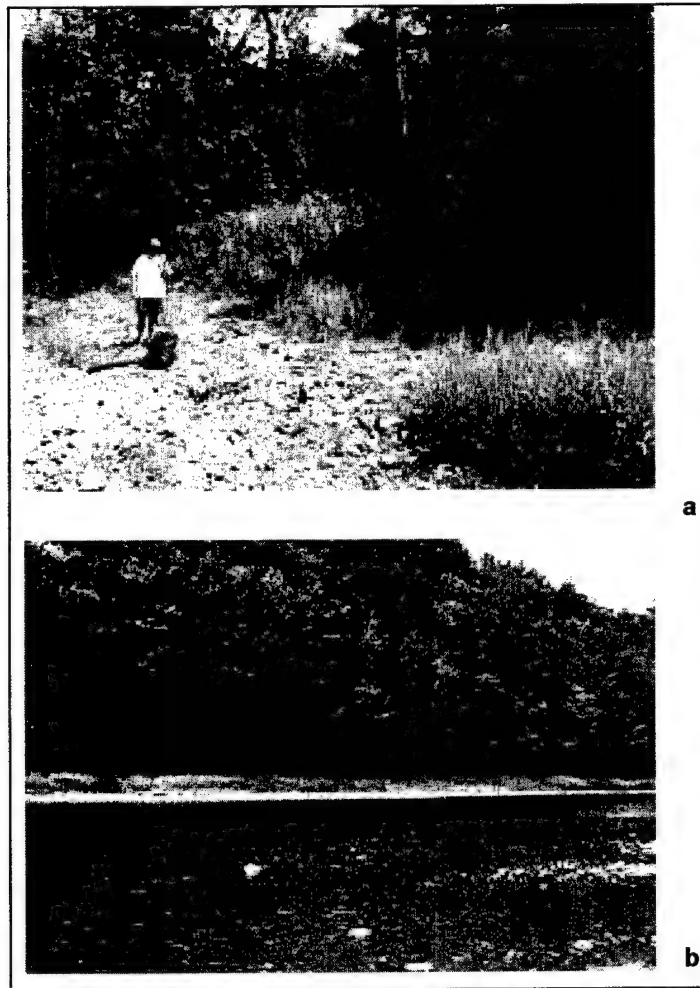
Field inspection showed that the initial banks (Figure 7) at this site were of low height with a gradual slope into the river that could easily be trafficked. However, there were secondary banks 8 to 10 ft high and a 70° to 90° slope above the initial banks within the vegetation strip that disqualified this as a crossing site. Along with the inability to determine vertical height from the imagery, the vegetation had substantially filled in areas that were open when the imagery was taken five years before this study.

Figure 7. Site 13: East (a) and west (b) banks. Trees in background of both photos hide steeper secondary banks.

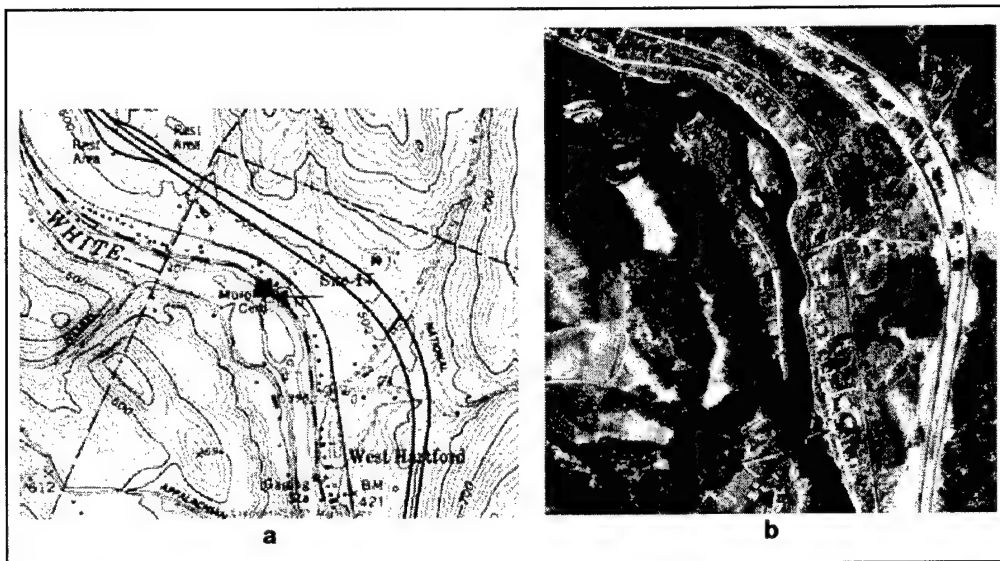
At site 14, it was thought the AVLB could be deployed between the river-banks and the smaller island just north of the larger island shown on the map (Figure 8). It can be seen in the aerial imagery that the river has widened the gap between the west bank and the large island. In addition, the smaller island off the northern tip of the large island is now practically nonexistent, essentially just ledge protruding above the water, which shows up as rapids in the imagery.

Figure 8. Site 14: Contour map (a) and aerial imagery (b) of possible AVLB site.

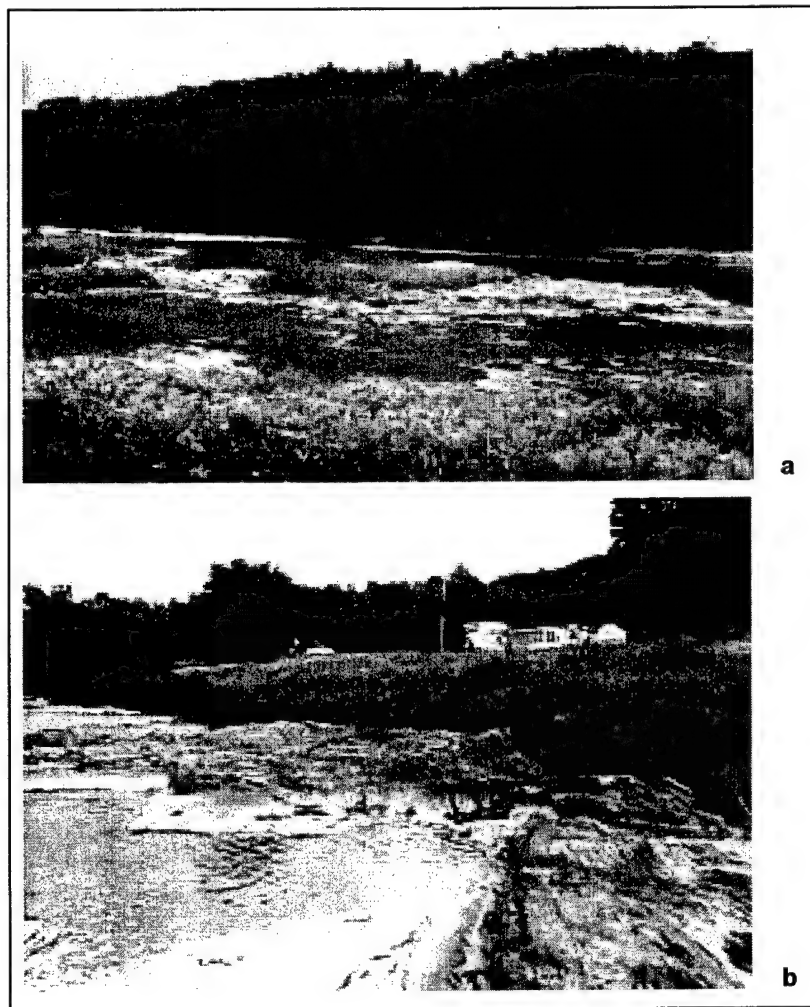
Figure 9a was taken looking toward the west bank with the ledge outcropping at the end of the large island visible in the middle of the picture. Measurements showed the distance between the west bank and the outcropping to be 20 to 25 m. The distance between the outcropping and the east bank was 35 to 40 m, both beyond AVLB capabilities. Although the west bank was gradual enough to provide access to the river, the foot of the east bank was jagged ledge outcropping that would be difficult to traverse. The river bottom was too uneven, with alternating deep and shallow spots, to allow either fording or rafting.

Figure 9. Site 14: East bank (a) and west bank (b) with small island.

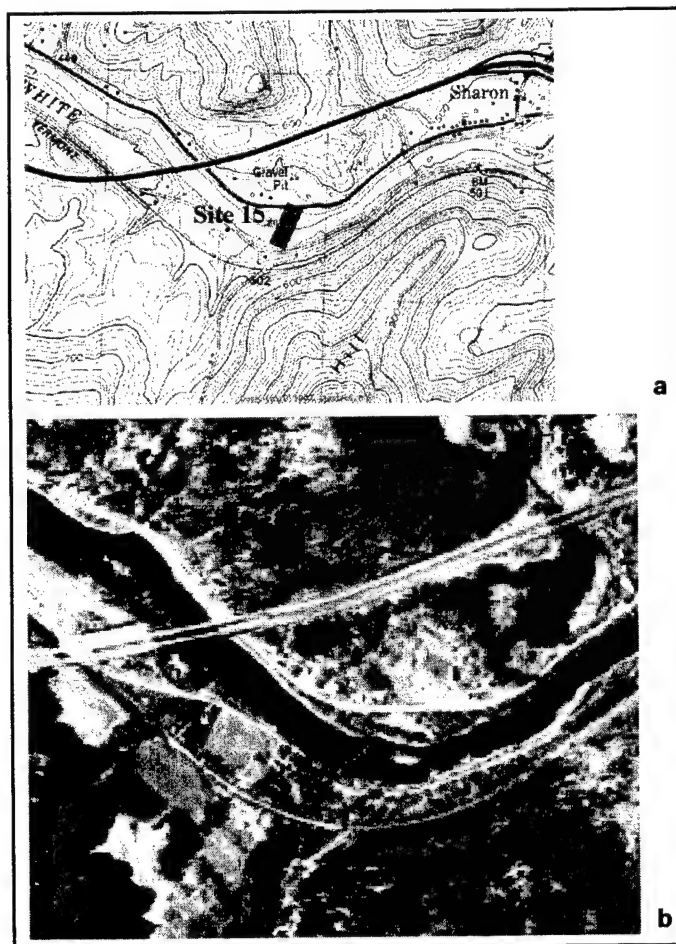
The aerial imagery of site 15 (Figure 10) shows an area at the river bend that appears to have a small island and some shallow features crossing the river just to the west of the island. Field inspection revealed that the river is too wide here for an AVLB, with no island or shallow feature present that matched the aerial imagery. Regardless of the river width, the west bank would have been too high an obstacle for crossing here with the AVLB or otherwise.

Figure 10. Site 15: Possible AVLB crossing contour map (a) and aerial imagery (b).

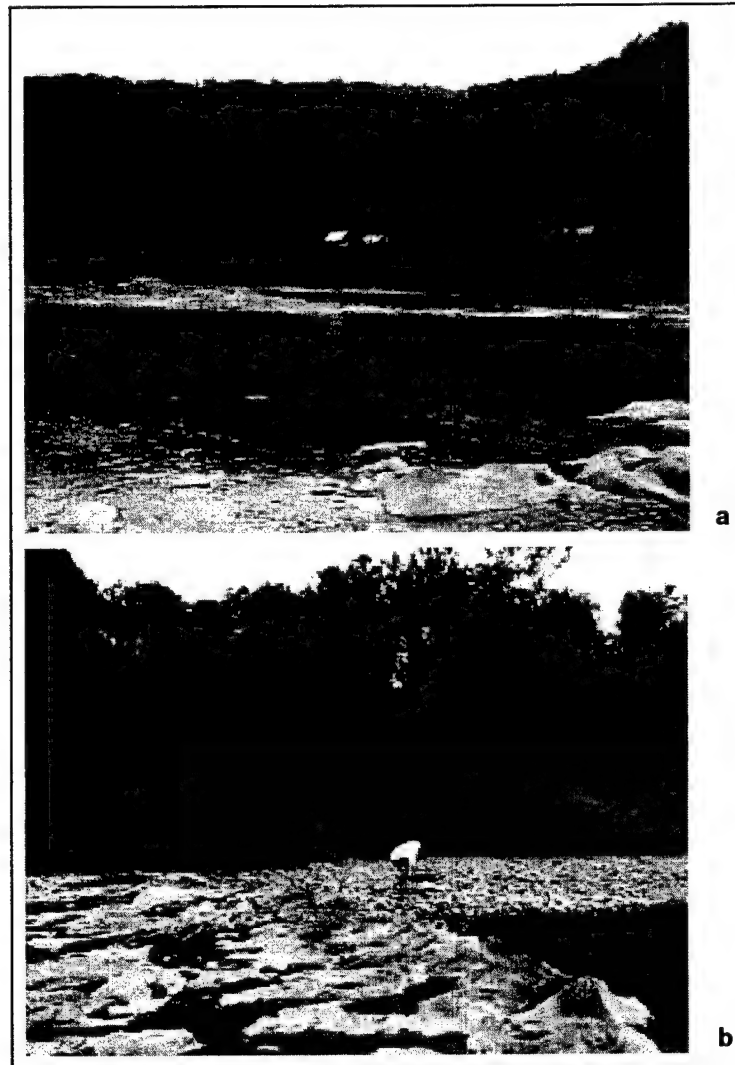
There is a gradual slope at the river's western edge (Figure 11a), but then an approximately 10-ft-high secondary bank rises at a 70° to 80° slope to a roadway above. The east bank (Figure 11b) was acceptable at about a 5-ft height and 20° slope at the worst, with small-diameter vegetation. The river bottom was gravel, with areas of exposed ledge that would have made vehicle movement difficult but possible.

Figure 11. Site 15: West bank (a) and east bank (b).

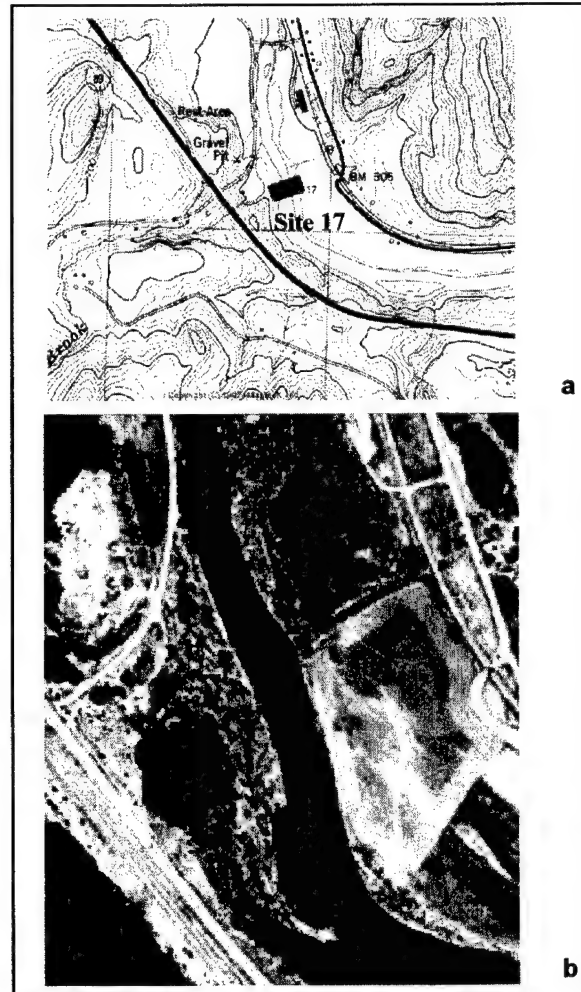
The map for site 17 (Figure 12) indicates a relatively large flat area on the east side of the river and narrower but still flat west bank at the river. The aerial imagery shows the flat area on the east side of the river to be open fields with little indication of a bank at the river. The west side has vegetation in the area shown on the contour map as an access strip to the river, but roads are visible throughout so the vegetation was not thought to be a major obstacle.

Figure 12. Site 17: Contour map (a) and aerial imagery (b).

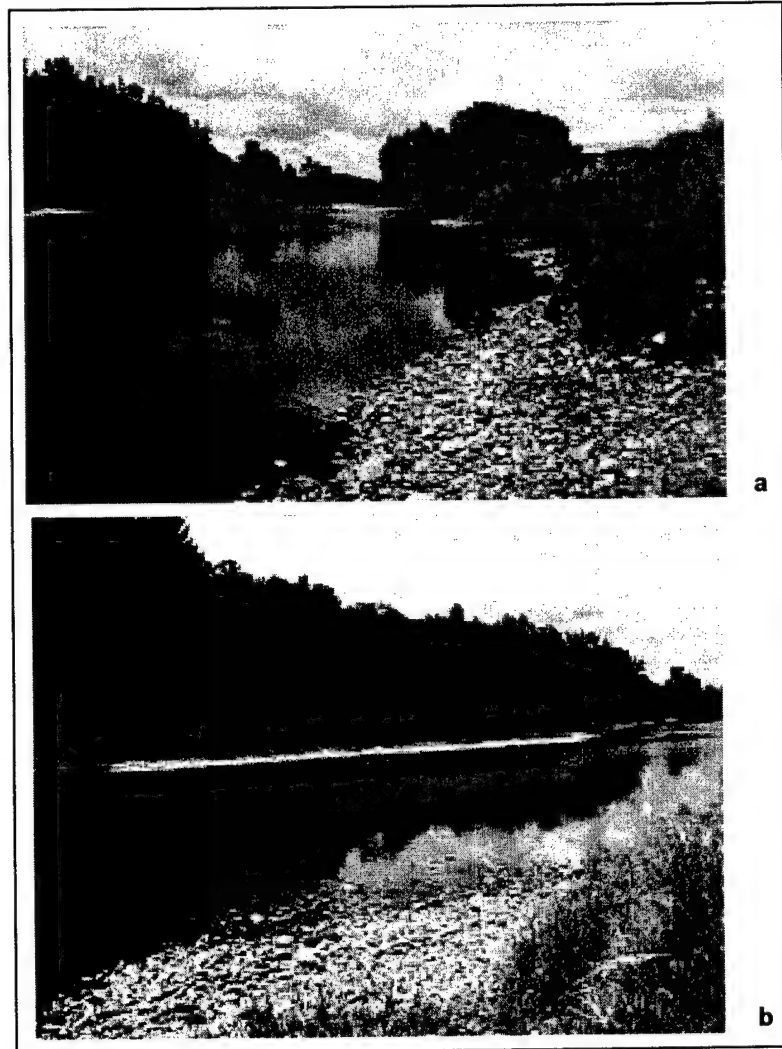
allow movement. Here again, the problem at this site was the inability to discern vertical height at the river's edge.

Figure 13. Site 17: (a) East bank with west bank access point in background and (b) west bank.

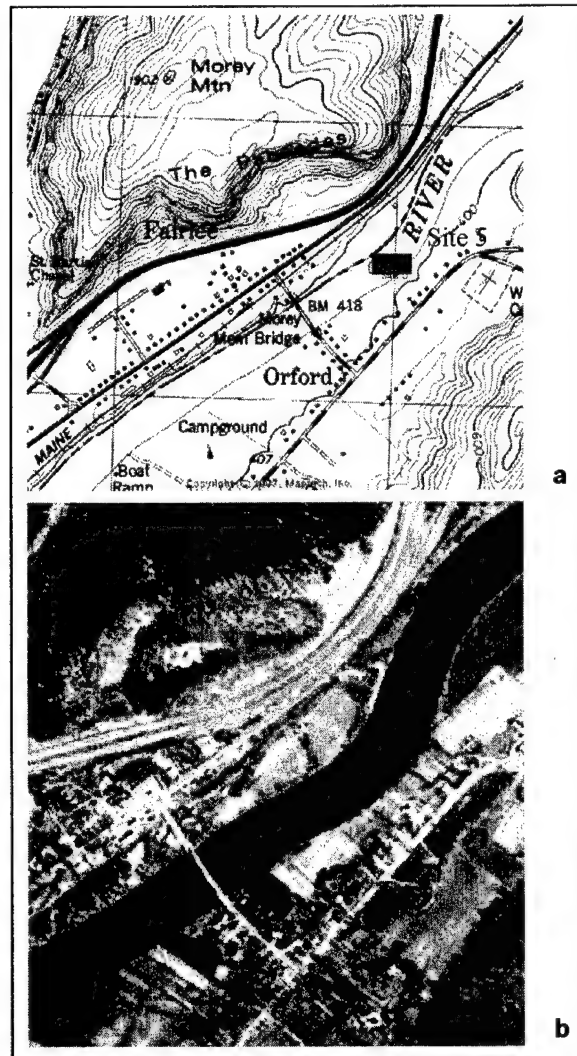
For comparison, the successfully identified sites are discussed below. In area 1, on the Connecticut River, site 5 (Figure 14) was considered a successful crossing site. The aerial imagery shows, just to the south of a large building, what appears to be a private road on the east bank leading down to the river. This was thought to be a good access point on the east side of the river, and the contour maps and imagery show the east side to be open fields with little slope.

Figure 14. Site 5: Contour map (a) and aerial imagery (b).

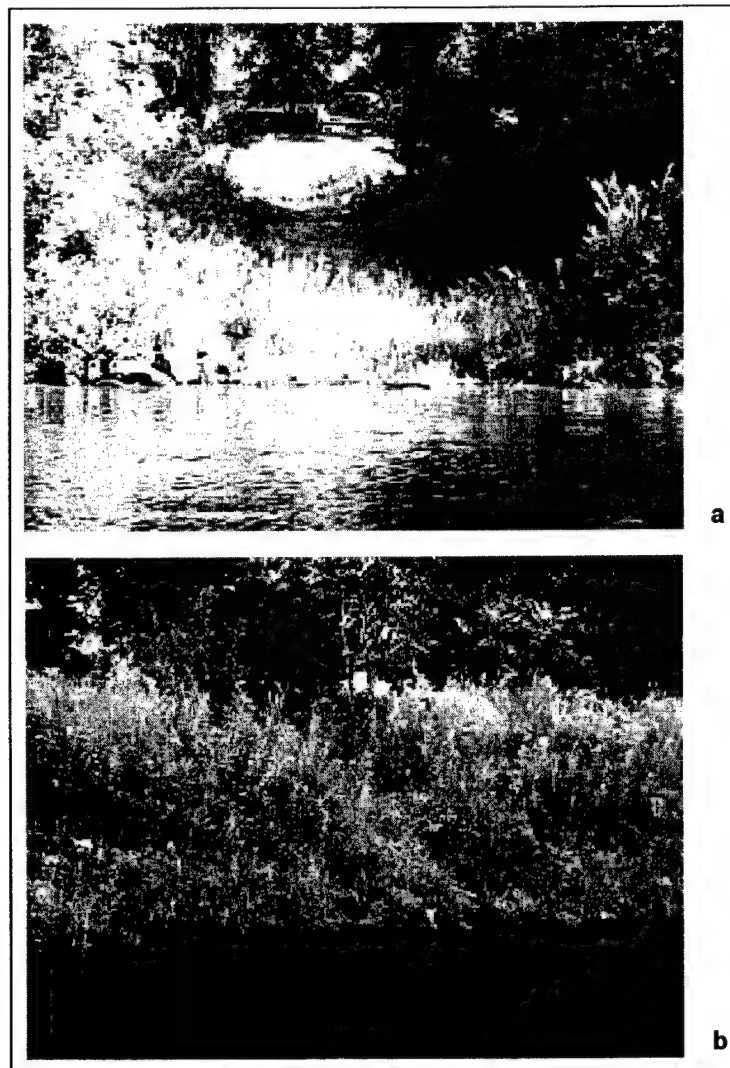
On the east bank (Figure 15a), the road leads down to the river; the approach here is good with little bank height at the water. The west bank (Figure 15b) is marginal, with one 10- to 15-ft-wide section of 3- to 4-ft bank height and about a 30° slope.

Figure 15. Site 5: (a) East bank with private road to river and (b) west bank. Actual west bank height is about 3 to 4 ft, but vegetation makes it appear higher.

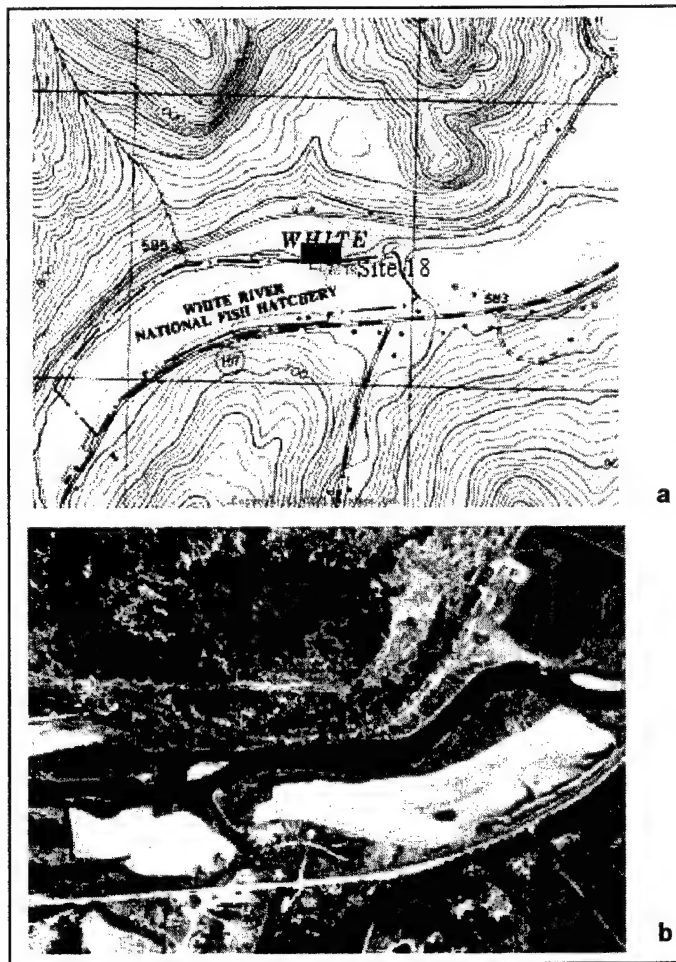
Site 18 in area 3 (Figure 16) on the White River was another successful crossing site. Note the change in the size and location of the island across from the mouth of the brook on the south side of the river between the date of the USGS map (mid-1980s) and the aerial imagery (1994). Another island, visible at the right hand edge of Figure 16b, has also been created; it does not appear on the contour map. This site was picked because the contour map shows an area of gentle slopes on both sides of the river near the fish hatchery land. The aerial imagery shows fields on the south side of the river with vegetation on the north side. There appears to be some kind of access road to the river on the north side visible just to the west of the island.

Figure 16. Site 18: Contour map (a) and aerial imagery (b).

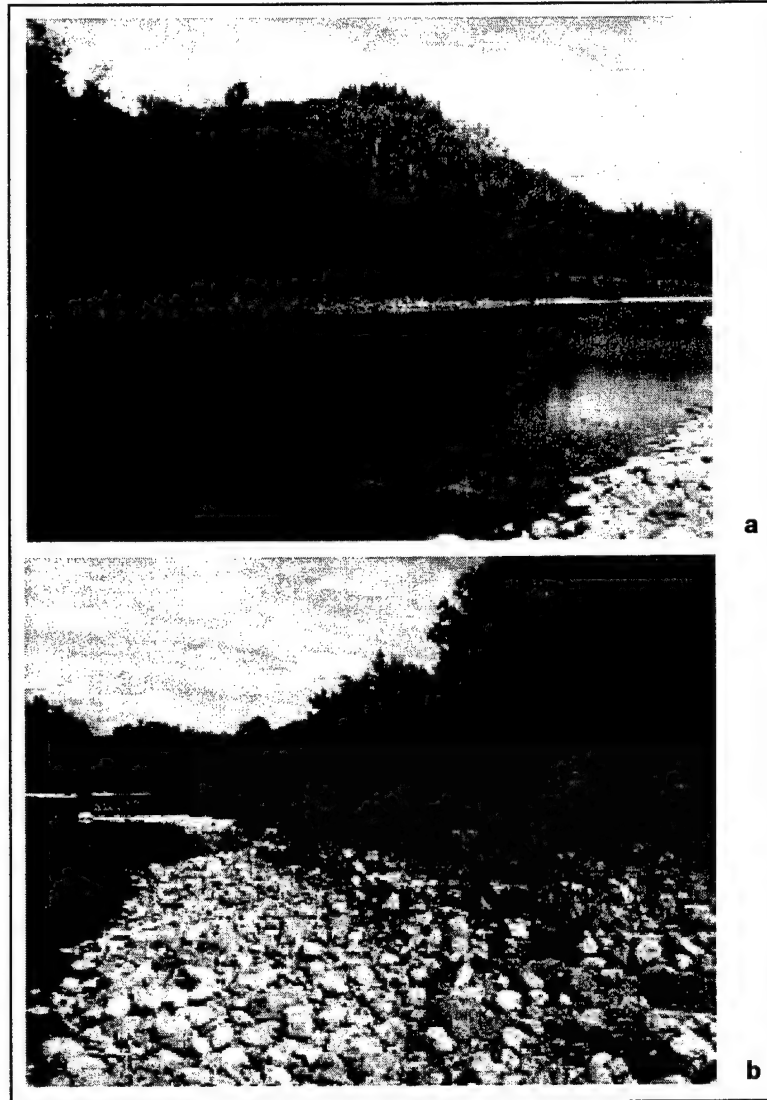
The banks at site 18 (Figure 17) are gentle enough to provide good access to the river, with stable soils reinforced by stone. The river itself has a stable bottom with some spots 3 to 4 ft deep but with areas that were fordable. As it turned out, the topography beyond the river on the south side has areas that are steep and covered in mature vegetation leading up to the fields shown in the aerial imagery, so it would be impossible to traffic a direct route to the highway over this terrain.

Figure 17. Site 18: (a) North side facing east and (b) south side facing east.

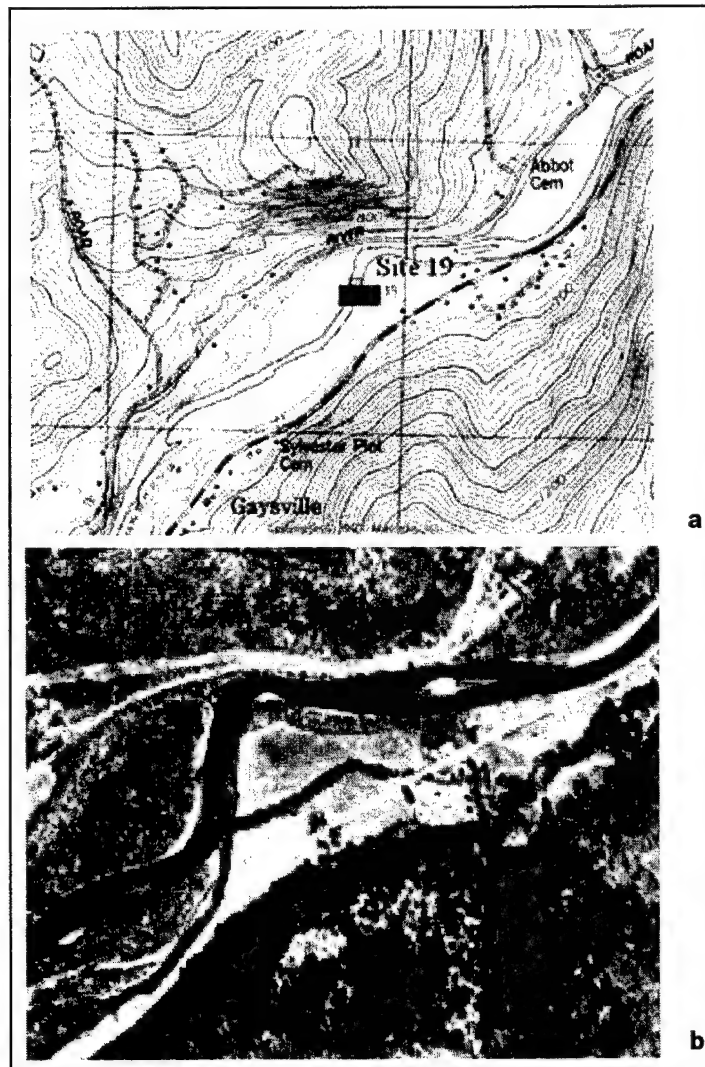
Site 19 (Figure 18) is the final acceptable crossing site identified remotely. It was chosen because the contour map indicates low slopes along the river with roads nearby. The aerial imagery shows the east side of the river as open field behind a vegetation line along the riverbank. The west side of the river had more vegetation but appeared to have open pathways within it.

Figure 18. Site 19: Contour map (a) and aerial imagery (b).

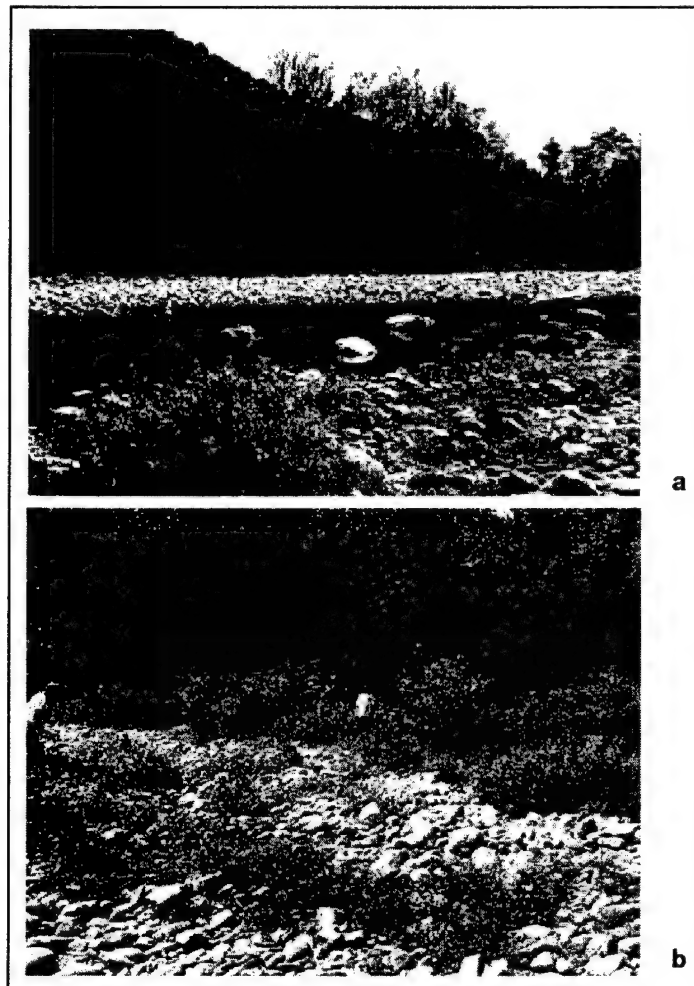
The site offers good access to the river on both sides (Figure 19) with low banks but with dense vegetation, mostly small-diameter (2- to 4-in.) trees with some larger trees at intervals that would allow vehicles to pass. The east bank also provides easy access immediately at the river. The bank has less than a 10% slope and is approximately 3 to 4 ft high. As on the east bank, however, the terrain beyond the river is very steep and would be impossible to traffic. Although this was considered a successful site for the purposes of this study, it is doubtful it would be used in actuality because of the difficulty of reaching the roadways beyond the river.

Figure 19. Site 19: (a) East bank (a cliff about 200 m from riverbank adjacent to road would be impossible to traffic) and (b) west bank.

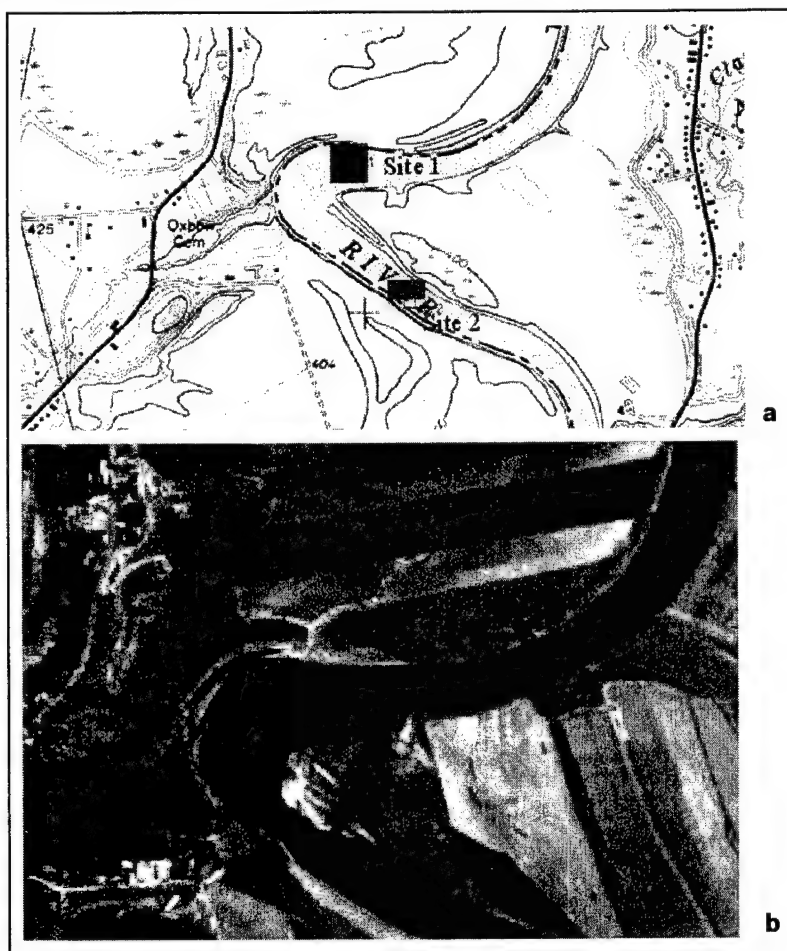
Figure 20. Sites 1 and 2: Contour map (a) (note marsh areas northwest of site 1 and east of site 2) and aerial imagery (b).

It is difficult to see indications of these marsh areas in the aerial imagery. The field inspections showed the land around both sites 1 and 2 was dry enough to support vehicles. If infrared (IR) imagery of the area had been available, it might have shown differences in the ground cover that would have indicated wet or dry conditions.

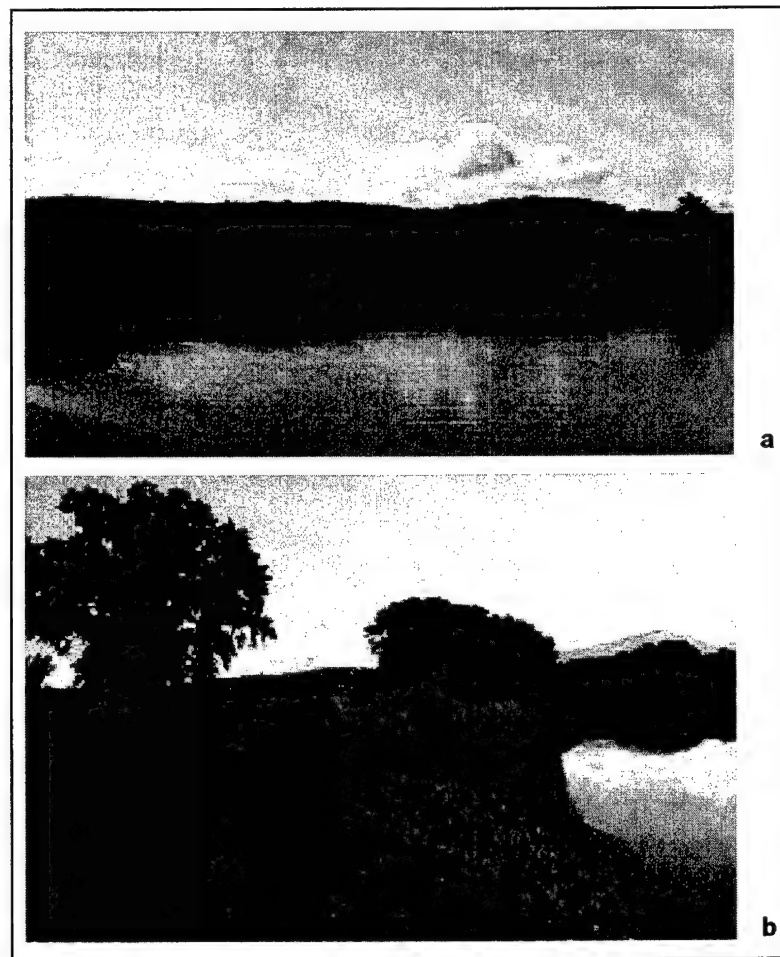
Figure 21 shows the east and west banks, at site 1, respectively. The east bank offers excellent access to the river with little bank and good soil for trafficking at the water's edge on the inside of the oxbow corner. The west bank has about a 12° slope over a total height of about 5 to 10 ft.

Figure 21. Site 1: (a) East bank looking back at oxbow turn in river and (b) west bank.

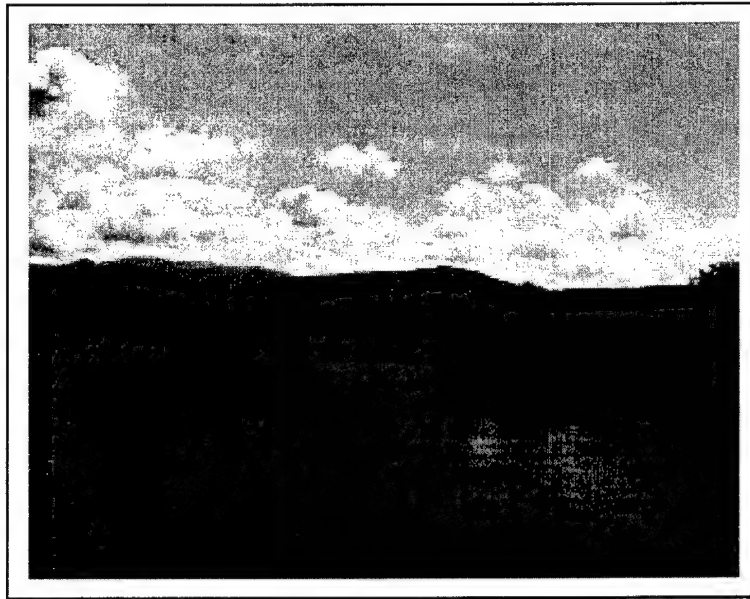
Site 2 has a similar east bank with good access to the river and no indication of soft ground beyond, as shown on the contour map. The west bank at site 2 (Figure 22) is interesting in that it is about 15 ft high with about a 26° slope. This is within the vehicle capabilities (see Table 1) but looks to be quite difficult to traffic from a raft. It was included as a crossing site, however, since it did fall within the capabilities.

Figure 22. Site 2: Steep west bank.

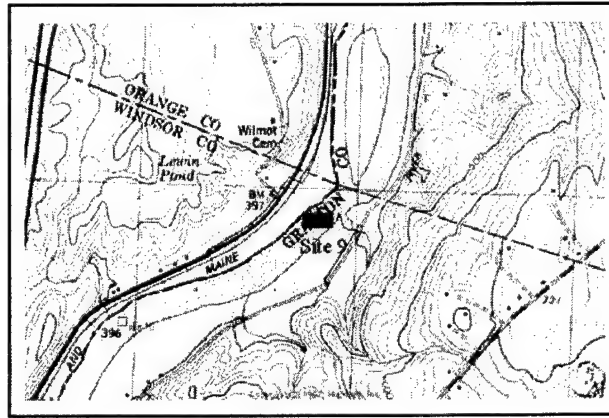
The next crossing site found during the field verifications was site 9, also in area 1 on the Connecticut River. It is about 0.6 miles north of remotely selected site 10 (Figure 23). There is no aerial imagery of this site. Site 9 was not chosen because it was thought wet ground might be present on the east bank, as indicated by the stream and small bay just to the north of the site. As it turned out, site 10 had to be rejected because the west bank was too high and steep, and the site 9 location was nearly ideal, with about a 2-ft-high west bank and an east bank with three ramps leading down into the water (Figure 24).

Figure 23. Site 9 found during river survey; just south is remotely selected site 10.

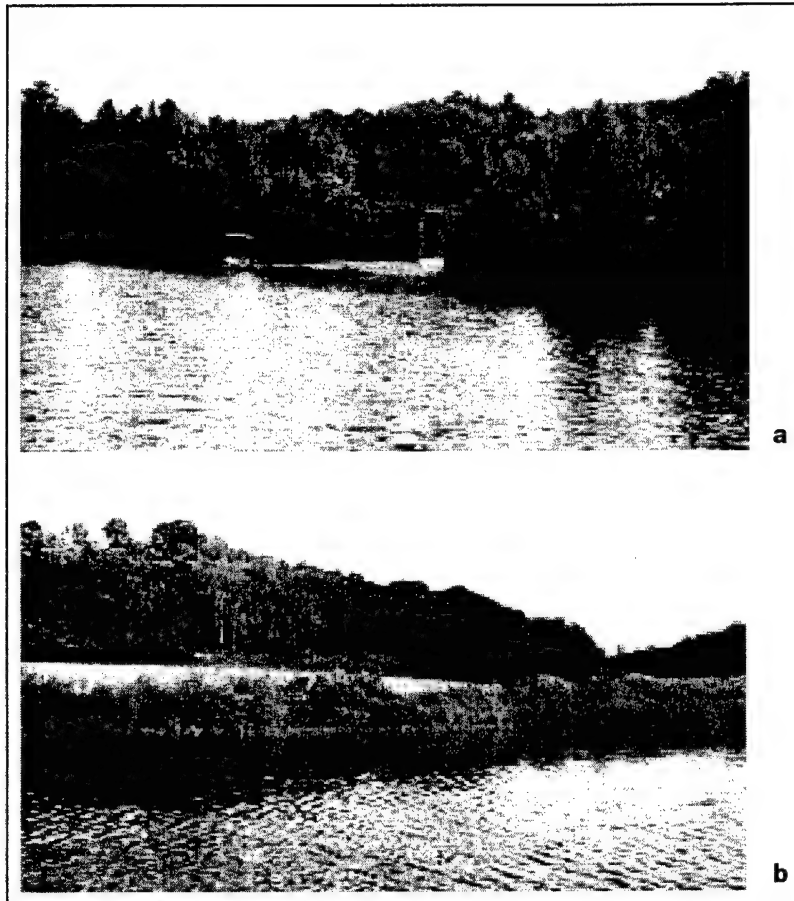
Figure 24. Site 9: (a) East bank, showing one of three ramps leading into river, and (b) west bank, where brush obscures approximately 2-ft-high bank.

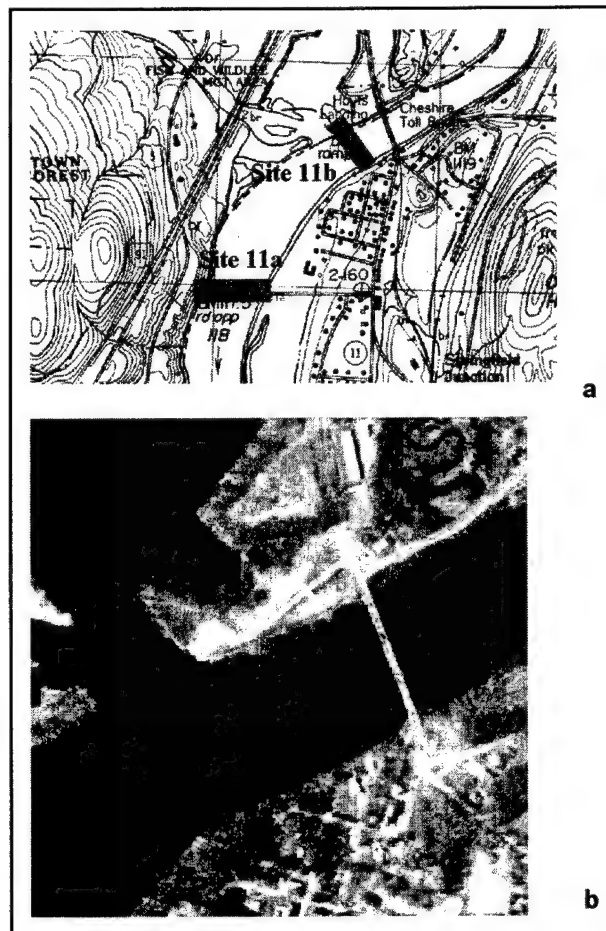
The final site picked during the fieldwork was site 11, found in area 2 on the Connecticut River (Figure 25). This site would have been marginal in a real hasty-crossing scenario because the raft would have a distance of 0.4 to 0.5 miles of water to traverse between the approaches. It was chosen, however, because it provides good access to the river and was the only possibility found in area 2. The west bank approach is a paved boat ramp, and the east bank is an open field with a low bank height.

Figure 25. Site 11: Contour map (a) and aerial imagery (b) of east bank approach at boat launch. West bank is just out of view in lower left portion of aerial image.

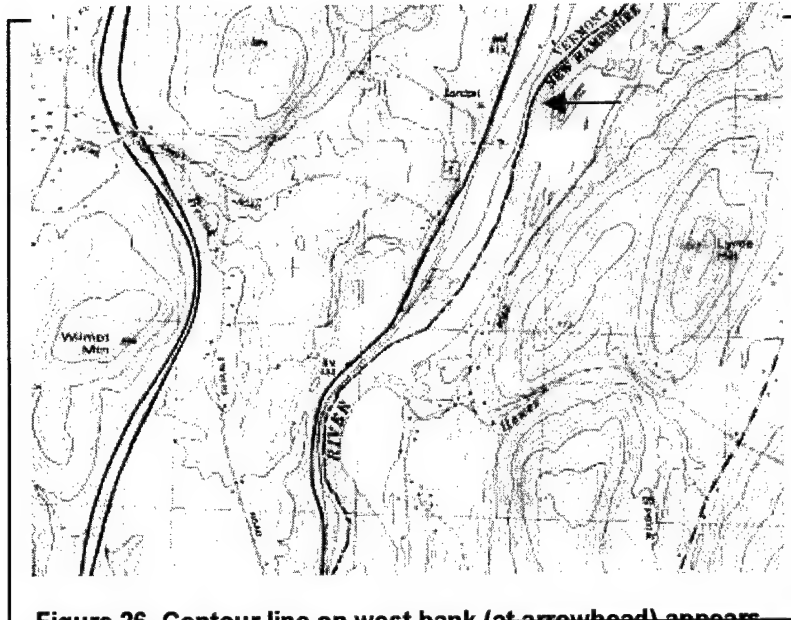
Figure 26. Contour line on west bank (at arrowhead) appears to indicate a bank that gradually disappears from north to south.

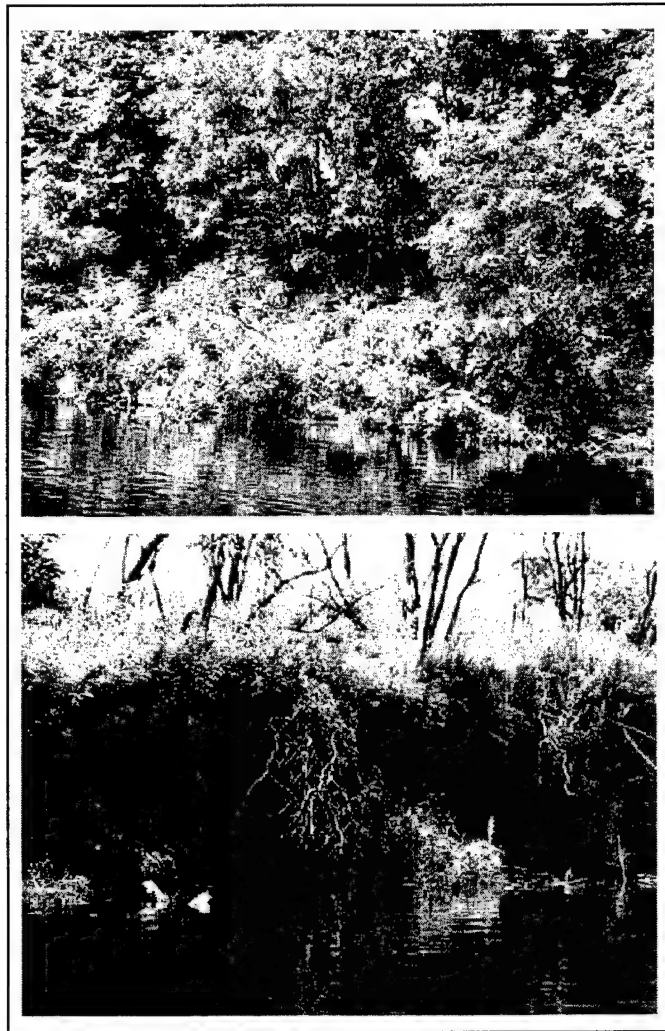
In actuality, there are steep banks at both locations (Figure 27).

Figure 27. Steep banks at locations indicated in Figure 26.

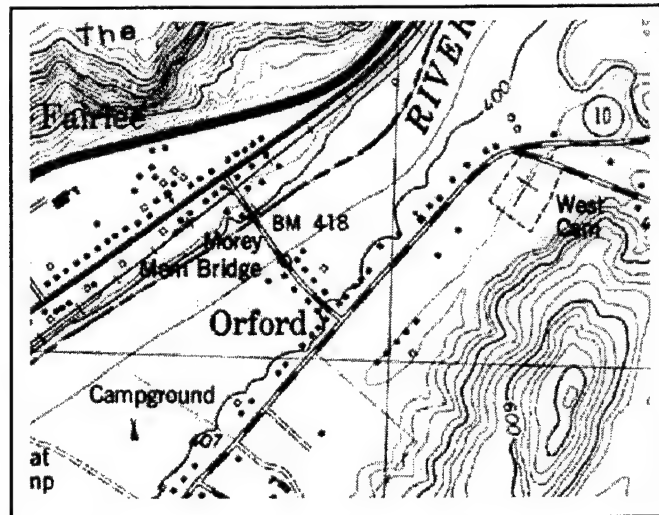
prone to ice formation, so bridges tend to be built at high points to keep them above ice jams or flood waters. At these locations, the banks tend to be steep and would be difficult, if not impossible, to traffic in most tactical bridging situations. As an example, Figure 28 is the USGS map of the Morey Bridge and surrounding terrain in area 1 of our study. Figure 29 shows the bridge at the west bank of the river. It is 30 to 40 ft above the water, and the bank angle here is too steep to traffic by the criteria used in this report. This condition is representative of the bridge locations on both of the study rivers.

Figure 28. Topographic map of Morey Bridge and surrounding area.

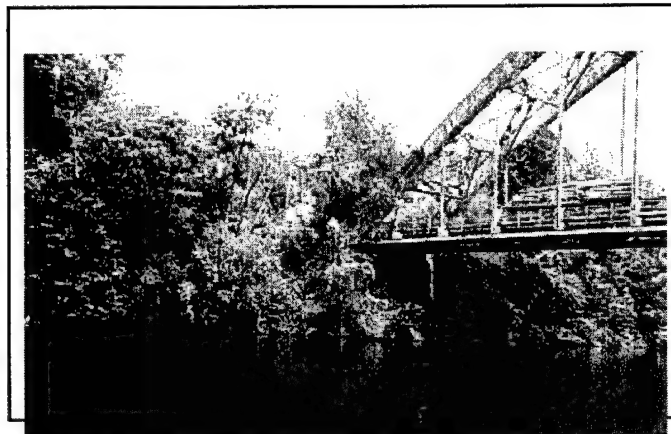
Figure 29. West end of Morey Bridge and bank.

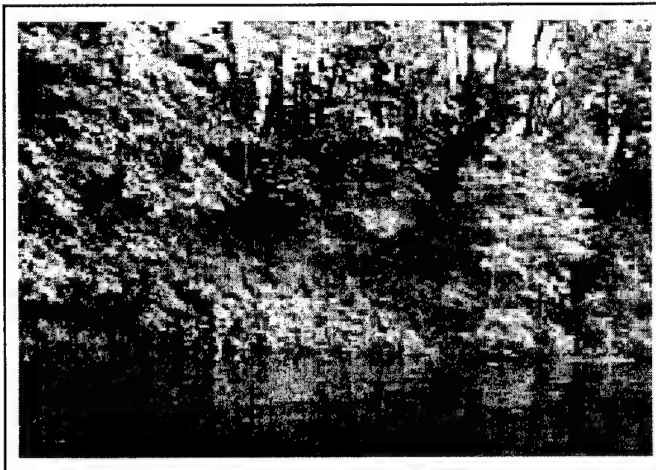
West bank of site 7.
The bank is steep,
20 to 25 ft high, and
it is low slope and
marsh grass.

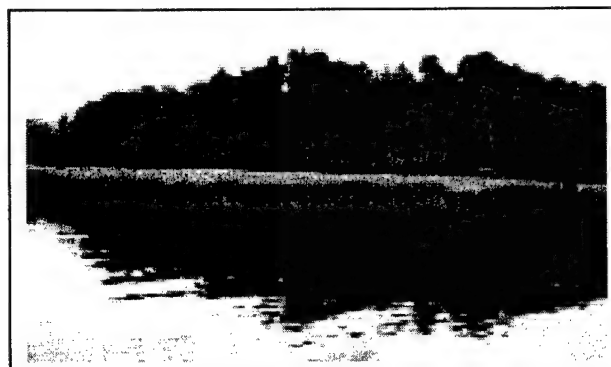
West bank of site 9. The west side is a field with about a 2-ft-high bank.

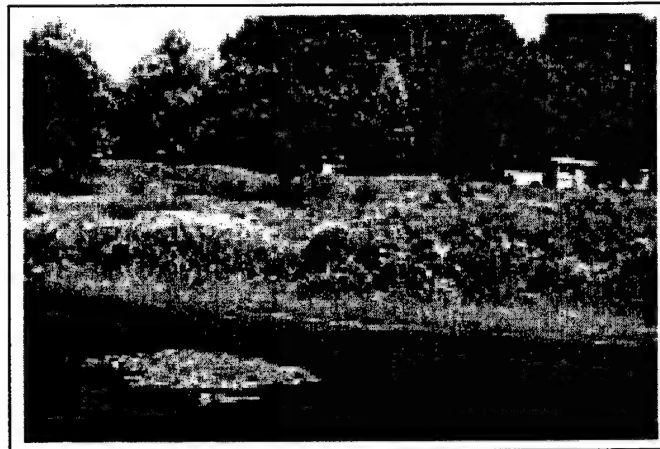
West bank south of site 10. It has an initial 24° slope, then it flattens slightly above.

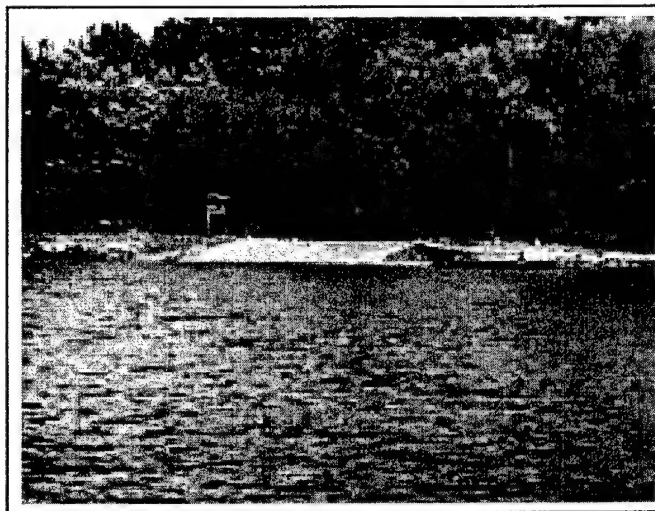
West bank of site 11. The boat ramp is excellent access.
